# MERCHANT AUTOMOTIVE

Merchant Automotive #10001  
Transfer Case Pump Upgrade Kit 1998-2007  
Installation Instructions

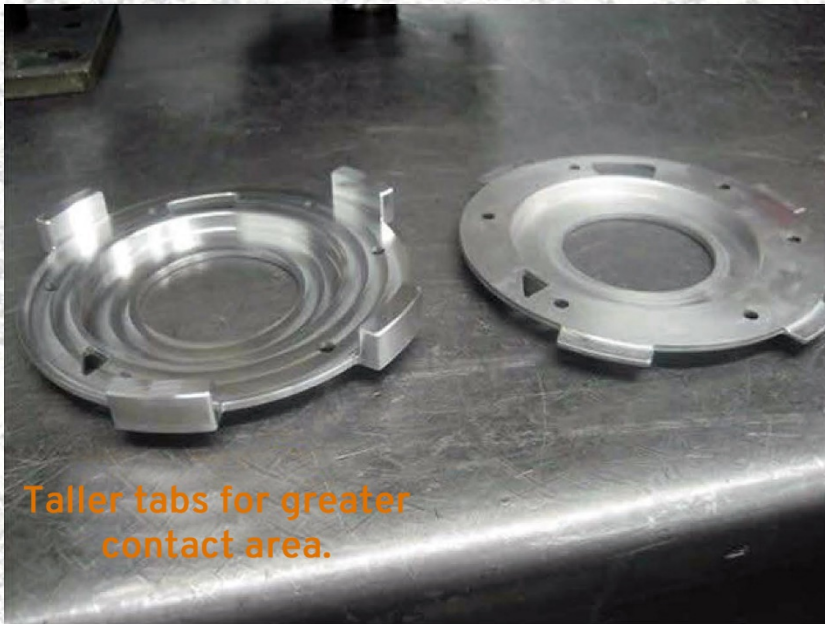
Taller tabs for greater contact area.

**01** The differences are quite obvious between the upgraded Merchant Automotive pump body over the stock unit. The MA part is CNC-machined from aircraft quality T-6061 aluminum with precision tolerances of less than 0.0001-inch. The larger tabs provide more surface area on the case to virtually eliminate rub through.

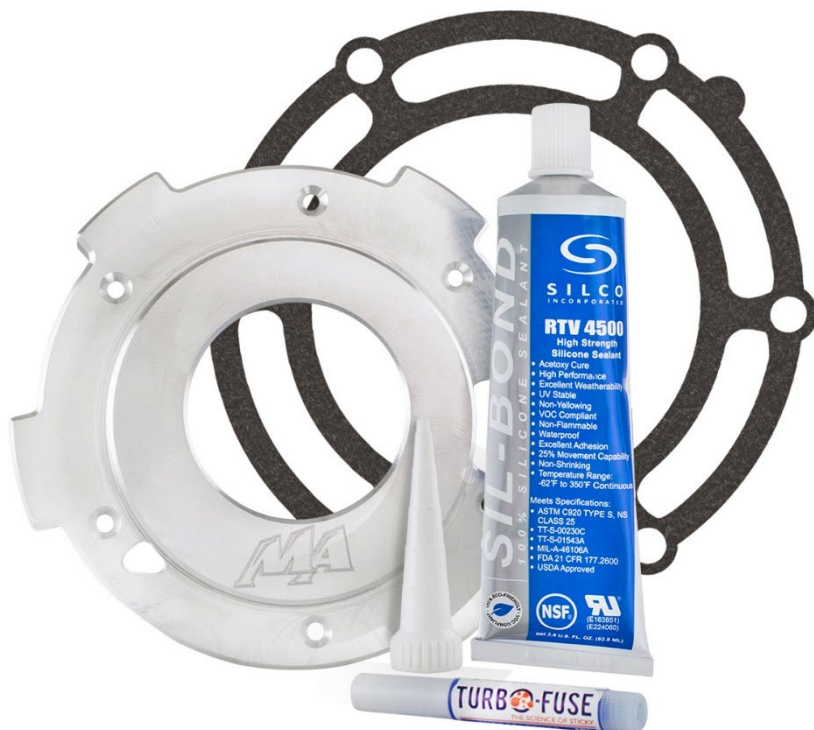
**05** Be sure to take note of the position of the mounting tabs and brackets on the housing. Use the image for reference upon reassembly to ensure they all go back in the proper position, or take a picture of your particular transfer case before disassembly with your smartphone or tablet. There is a series of bolts with cup-washers around the perimeter of the case. The perimeter bolts are all 10mm hex head with the exception of one that uses a 15mm hex head as it is also a bracket mount bolt.

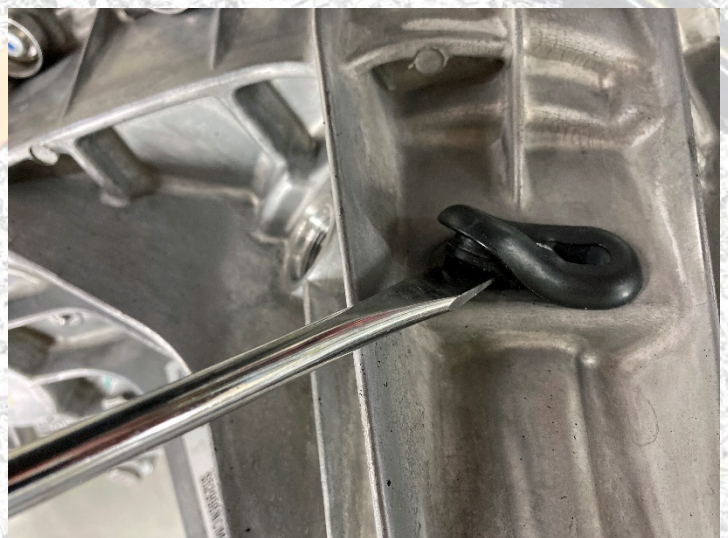
**08** You will see a snap ring under the plug as shown.

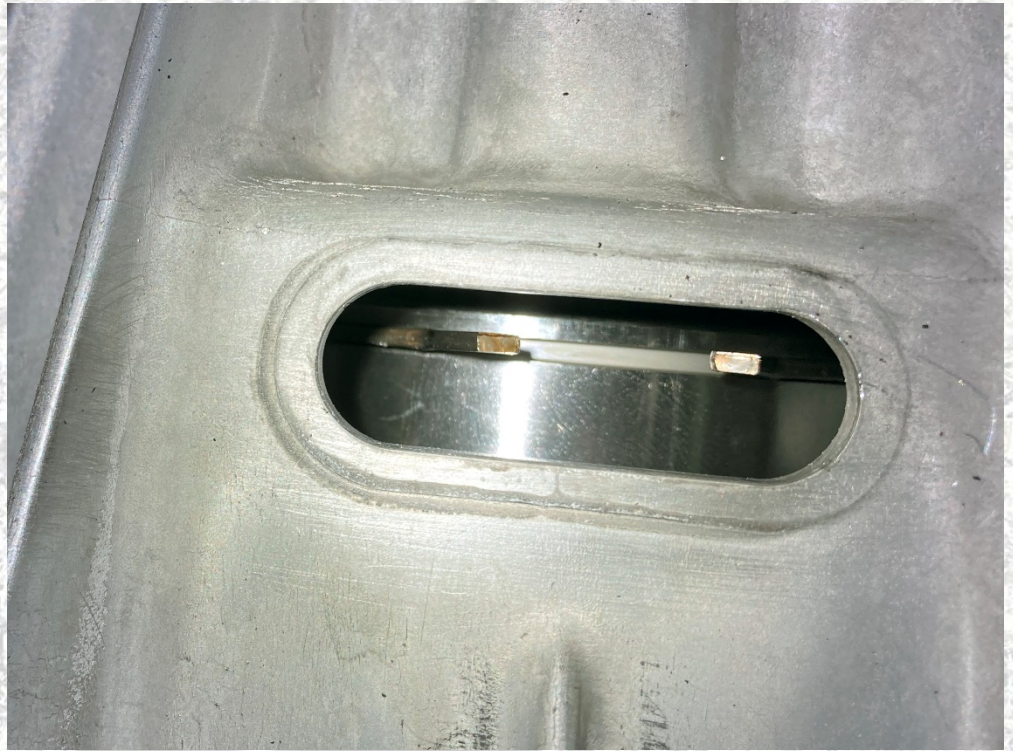
**09** Next use a 19mm or 3/4-inch box-end wrench or deep socket to remove the speed sensor. **DO NOT** use an impact gun, on the speed sensor, it is plastic and will break.

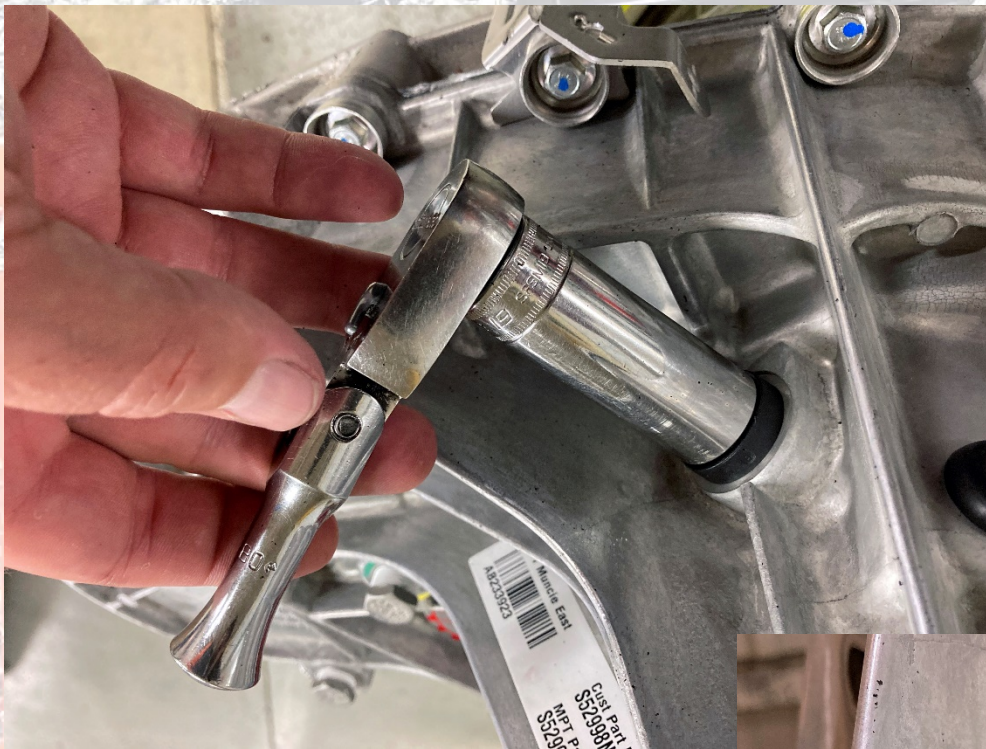
**10** You can see the reluctor wheel inside the case once the speed sensor is removed.

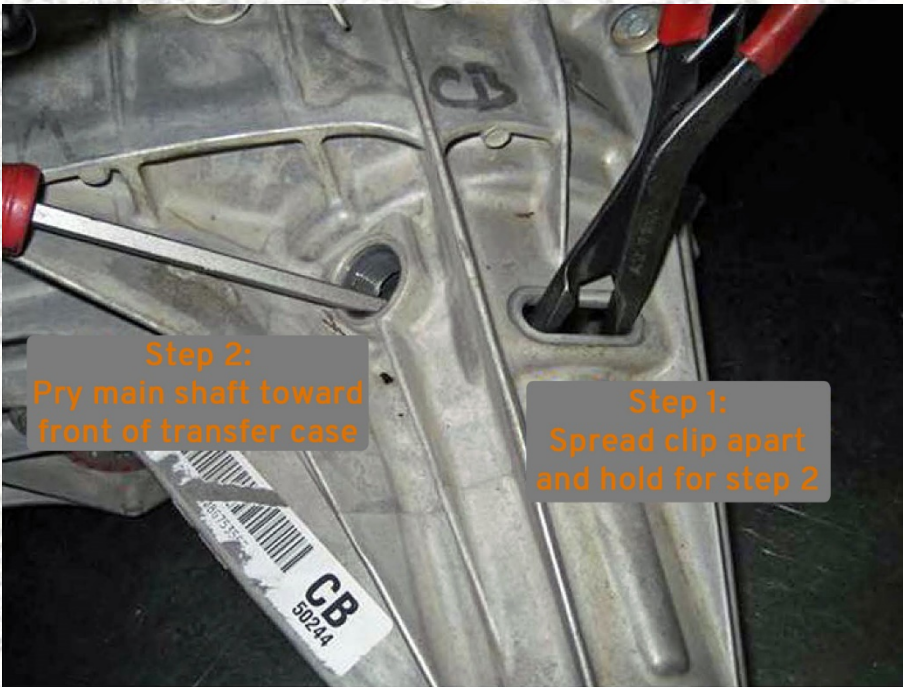
**Step 2:**  
Pry main shaft toward  
front of transfer case

**Step 1:**  
Spread clip apart  
and hold for step 2

**11** Using snap ring pliers and a large flat blade screwdriver or pry tool, open the snap ring then gently pry on the reluctor wheel pushing it forward toward the front of the transfer case. This will release the rear support bearing from the rear case housing.

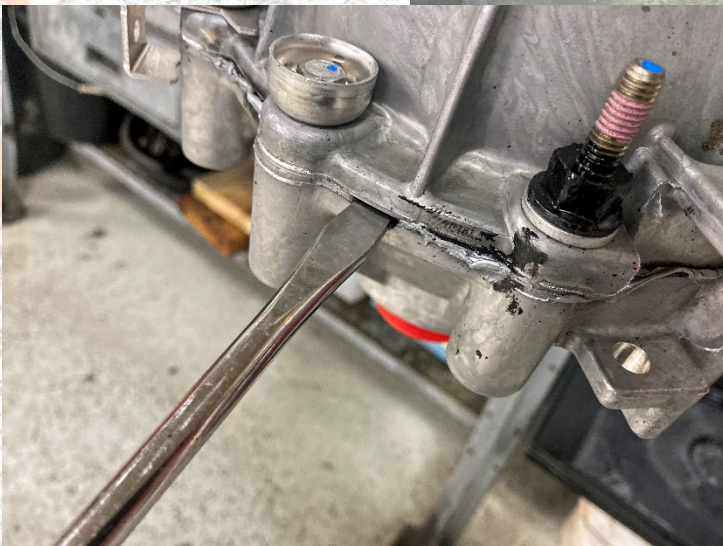
**14** Separate the transfer case rear housing by pulling it away from the rest of the case. At Merchant Automotive, we find it easier to work on a transfer case by propping the unit in an upright position as shown.

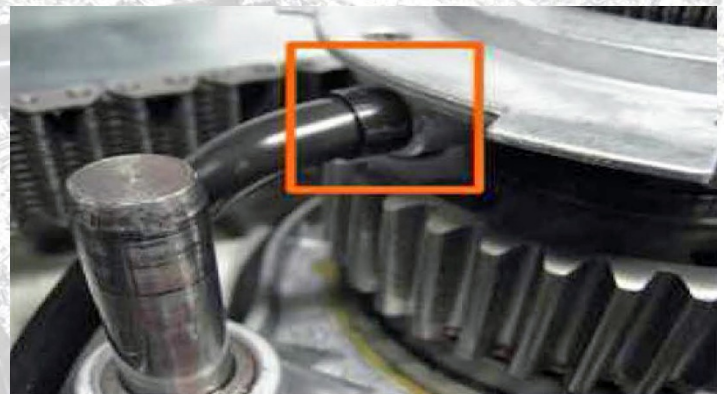
**19** Here is the stock pump assembly removed from the transfer case for the upgrade installation.

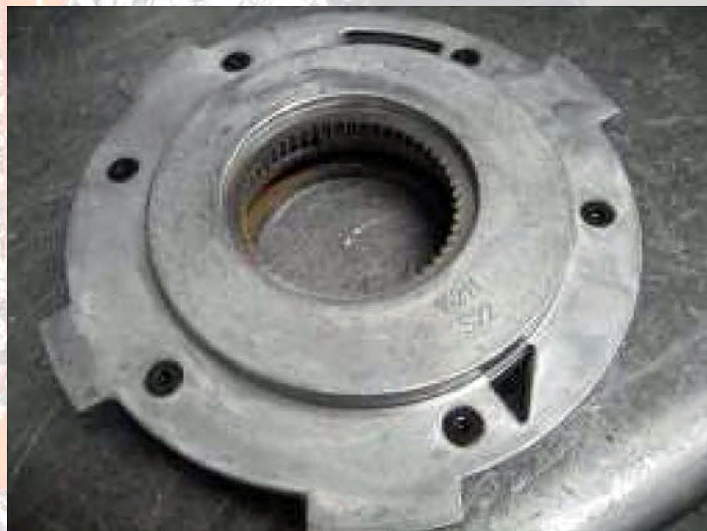
**20** Take note of the O-ring seal in the pump that seals the pickup tube. This O-ring must be in place during reassembly; it may be easier to assemble if you carefully remove the O-ring from the pump and install it on the pickup tube before reinserting it into the transfer case pump during reassembly.

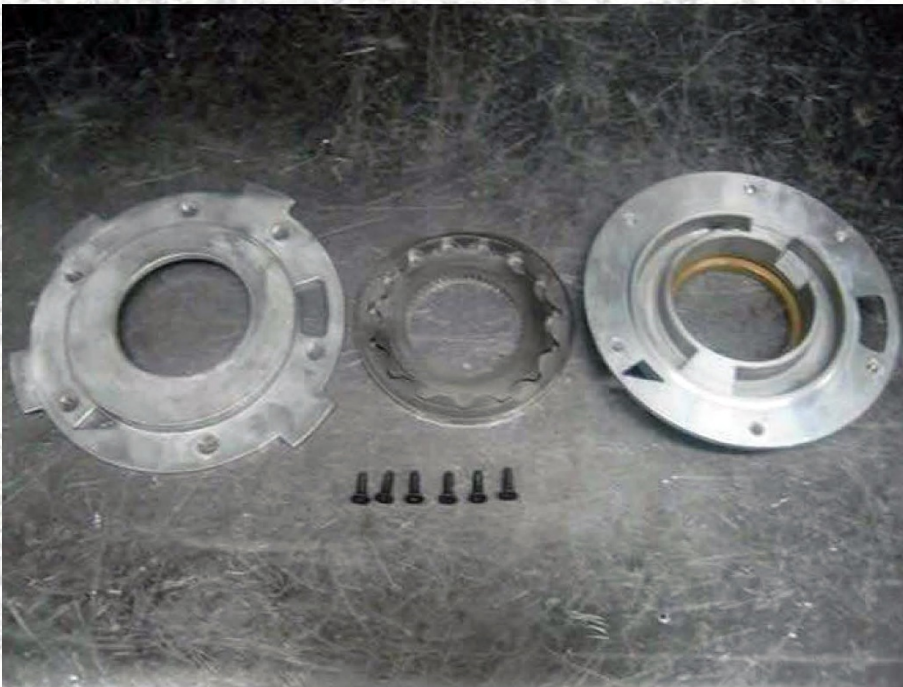
**21** Using a T-15 Torx screwdriver or bit remove the six screws holding the pump together. This image shows a disassembled view of the pump. Clean and dry all parts. The pump body may be discarded, (*top plate of the pump only, the gear set, screws and bottom will be reused*), as it will not be reused.

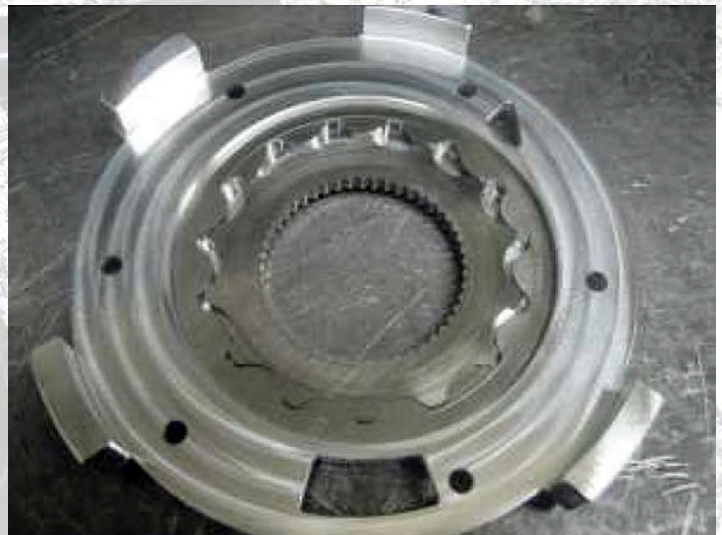
**22** Place the MA pump upgrade with the tabs facing up on the work bench then load the gears into the cover. After positioning the gears as shown, place a few drops of oil on the gears to help with the initial lubrication.

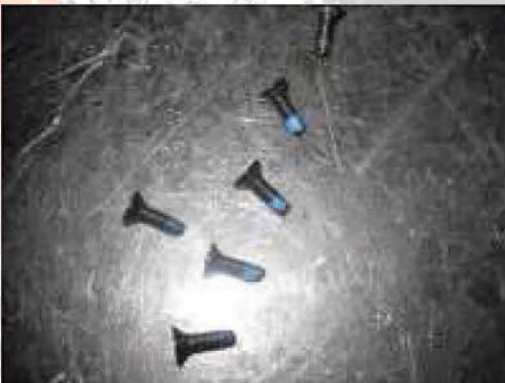
**23** Use the supplied blue threadlocker to apply a small drop on the threads of each of the six screws that hold the pump together as shown.

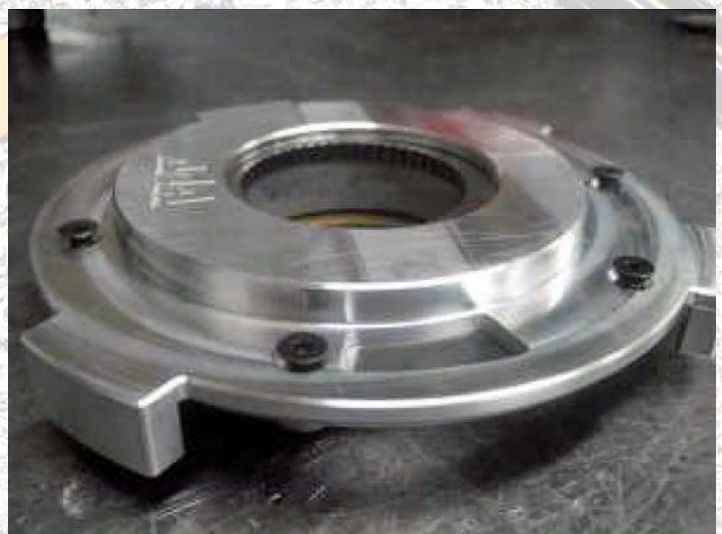
**24** Reassemble the pump, first starting each of the screws by hand a few threads then draw them tight in a crisscross pattern to ensure that the housing draws together evenly. The screws only need to be snugged; do not use excessive force to tighten them. Torque should be about 80 in-lbs, with a good rule of thumb would be to tighten them with a screwdriver type driver handle firmly. After tightening, verify that the pump gears still rotate smoothly in the housing.

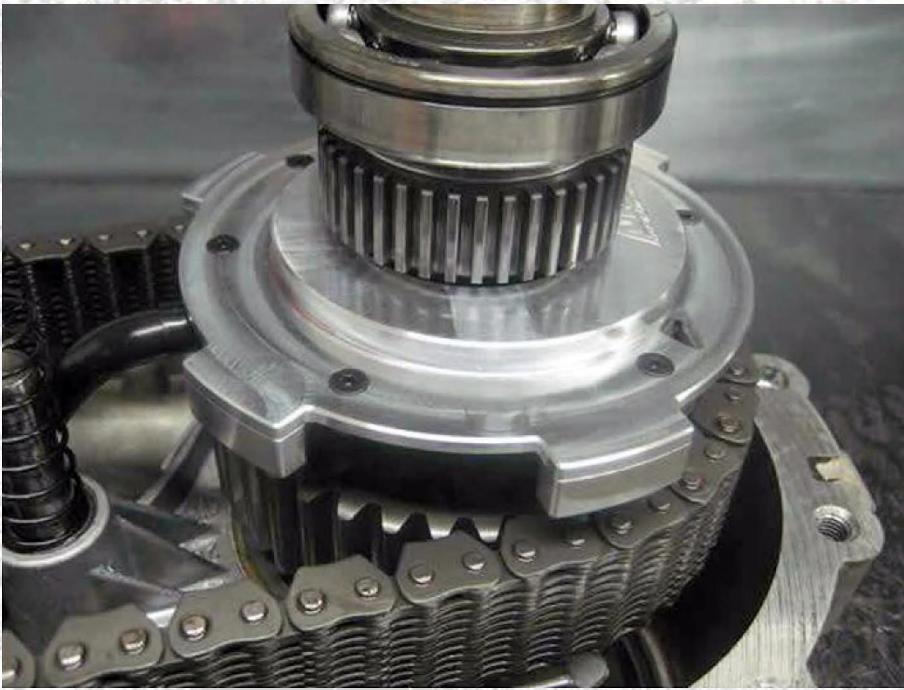
**25** Begin to reassemble the transfer case by reinstalling the pump, reluctor wheel and support bearing on the main shaft followed by the snap ring. (Verify that the stepped edge of the reluctor wheel is facing the pump and that the snap ring groove in the bearing race is on the top side of the bearing as shown.) Then reinstall the pickup tube in the pump housing making sure that the O-ring is intact and properly positioned.

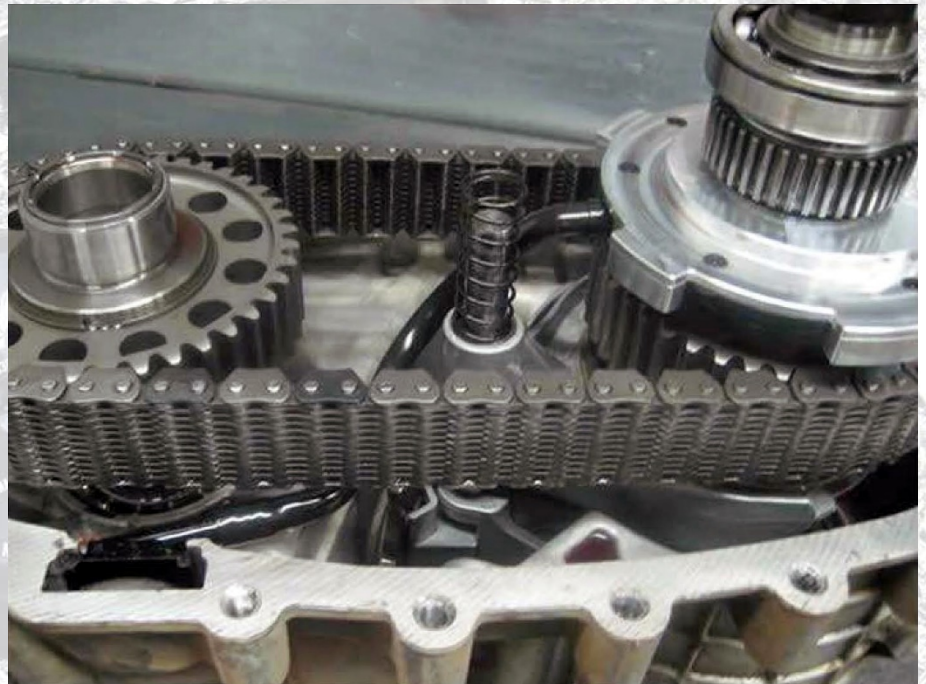
**26** This image shows what the inside of the transfer case should look like after reassembly. Verify that the spring is placed on the shift shaft as well.

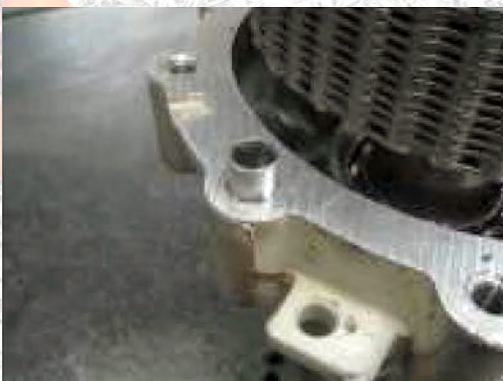
**27** Locate the dowel pins (they could be in either half of the transfer case housings) and place them in the front half of the transfer case. One dowel pin is required on each end of the transfer case; the location is identified by the counter bore in the case half. **BOTH** of the dowel pins **MUST** be installed or severe damage to the transfer case could occur.

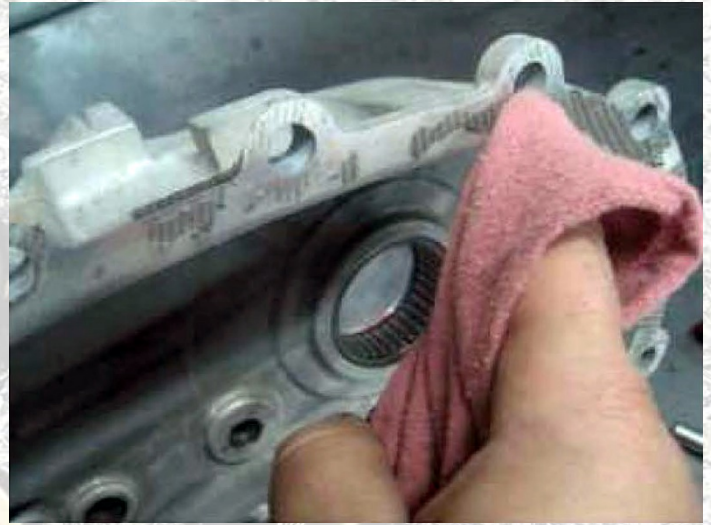
**28** Cleaning the old silicone sealer off the case halves is actually pretty easy. Use a rag and simply scrub it off as shown in the image, you may also use a red Scotch-Brite pad to clean the case halves and remove the old silicone. Notice that the flange has a rough surface finish; this is intentional to promote a good bond with the silicone sealer between the case halves. Thoroughly clean the flanges with brake cleaner or a similar product to remove all oil and residue. Silicone will not seal properly if any oil or residue is present. Failure to ensure the area is completely clean could result in a leak.

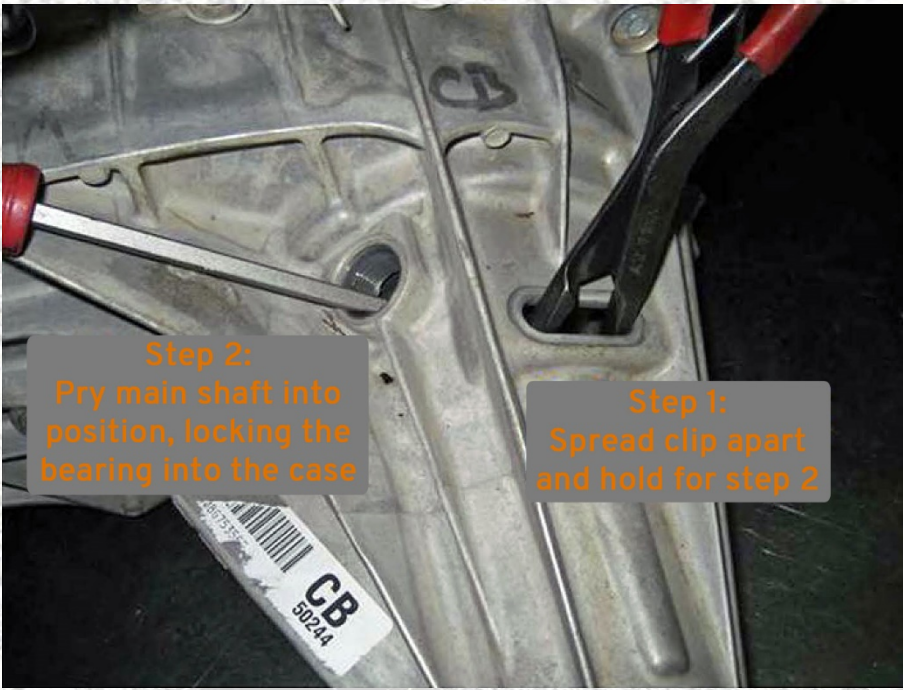
**Step 2:**  
Pry main shaft into position, locking the bearing into the case

**Step 1:**  
Spread clip apart and hold for step 2

**31** Spread open the snap ring through the access hole in the rear case half while using a large flat head screwdriver or similar pry tool to slide the mainshaft support bearing into place locking it into the rear case housing.

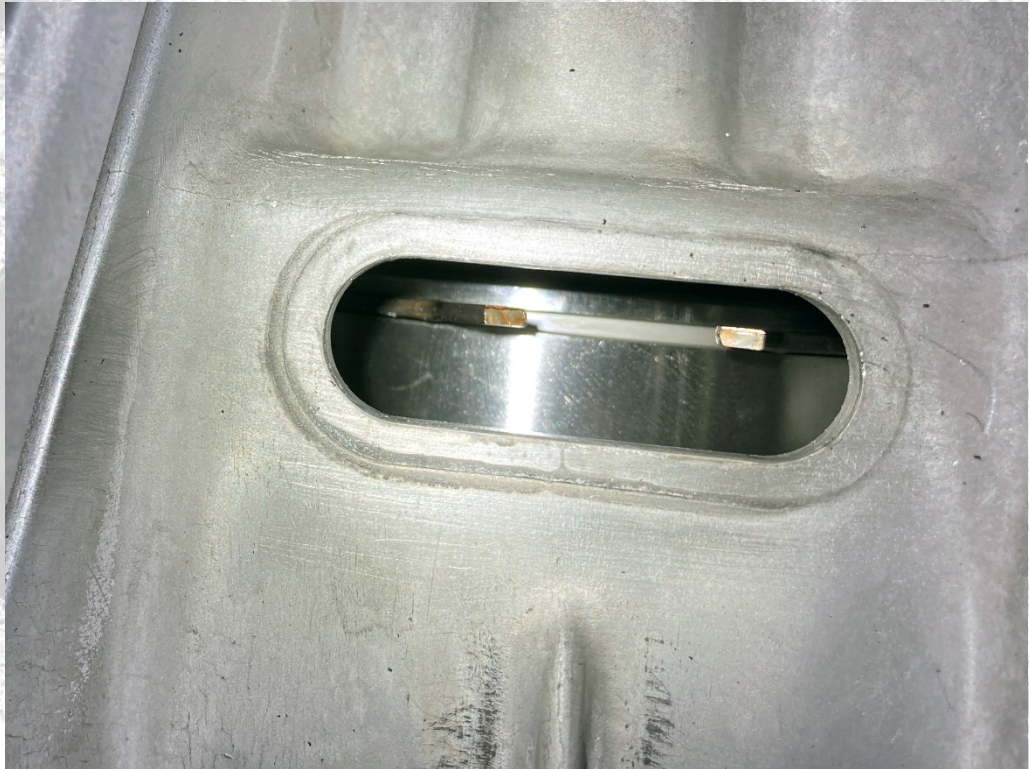
**32** Visually verify that the snap ring is locked into place in the bearing and in the case housing.
